Smoke and Dye Testing Summary

High Level Sewershed

Run Summary

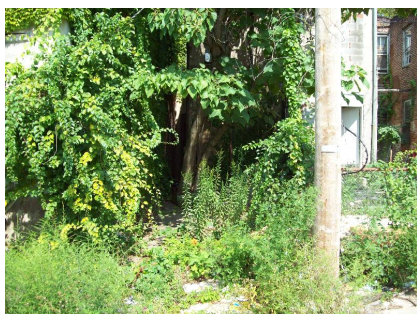
Picture \S1028-227-OB01-P01.jpg

Source Cleanout

Location Yard - back

Comments Smoke from cleanout in back yard. 1547 Clifton Ave.

Comments Back of house, 1547 Clifton Ave.

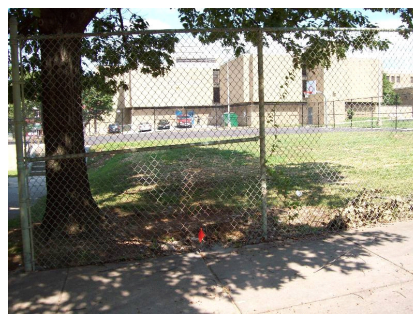
Picture \S1028-227-OB02-P01.jpg

Source Service Lateral

Location Sidewalk

Comments Smoke from service lateral underneath sidewalk. 2235 Fulton Ave.

Comments Side of school building, 2235 Fulton Ave.
